File No. 18-453.1
April 13, 2018

Subject: **GEOTECHNICAL MEMORANDUM**
Robertson Park Rodeo Stadium Seating
Livermore, California

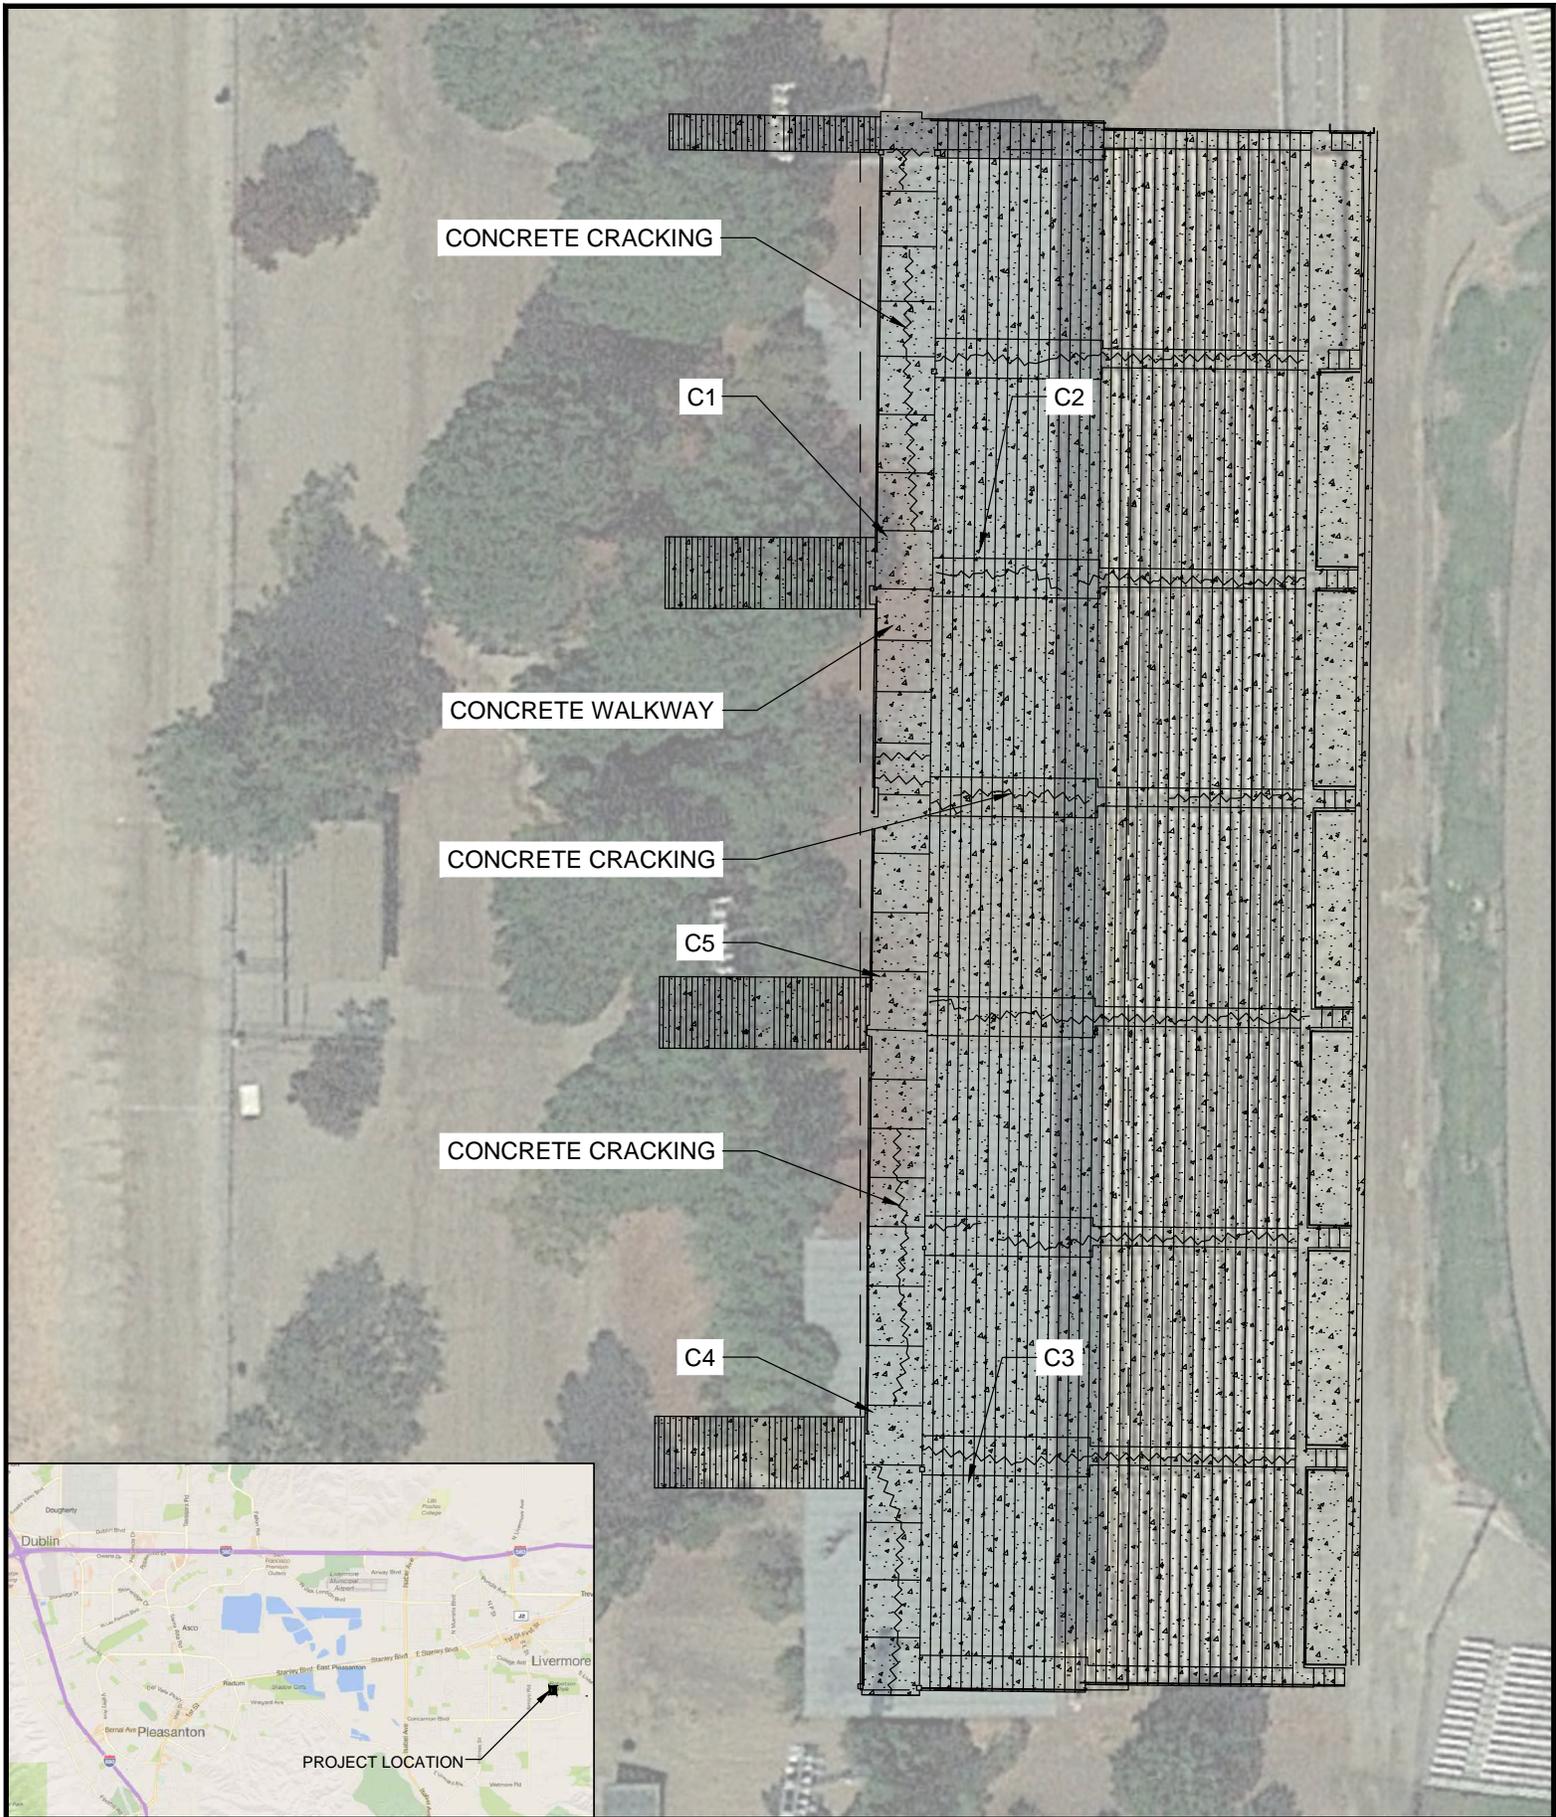
Figure 1-Exploration Map
Laboratory Test Results

We planned the general core locations based on the proposed improvements and discussions with O'Dell Engineering. We show the core locations on the Figure 1.

The boring locations shown on Figure 1 are based on visual comparisons made in the field between site features and features shown on aerial mapping, therefore they are approximate.

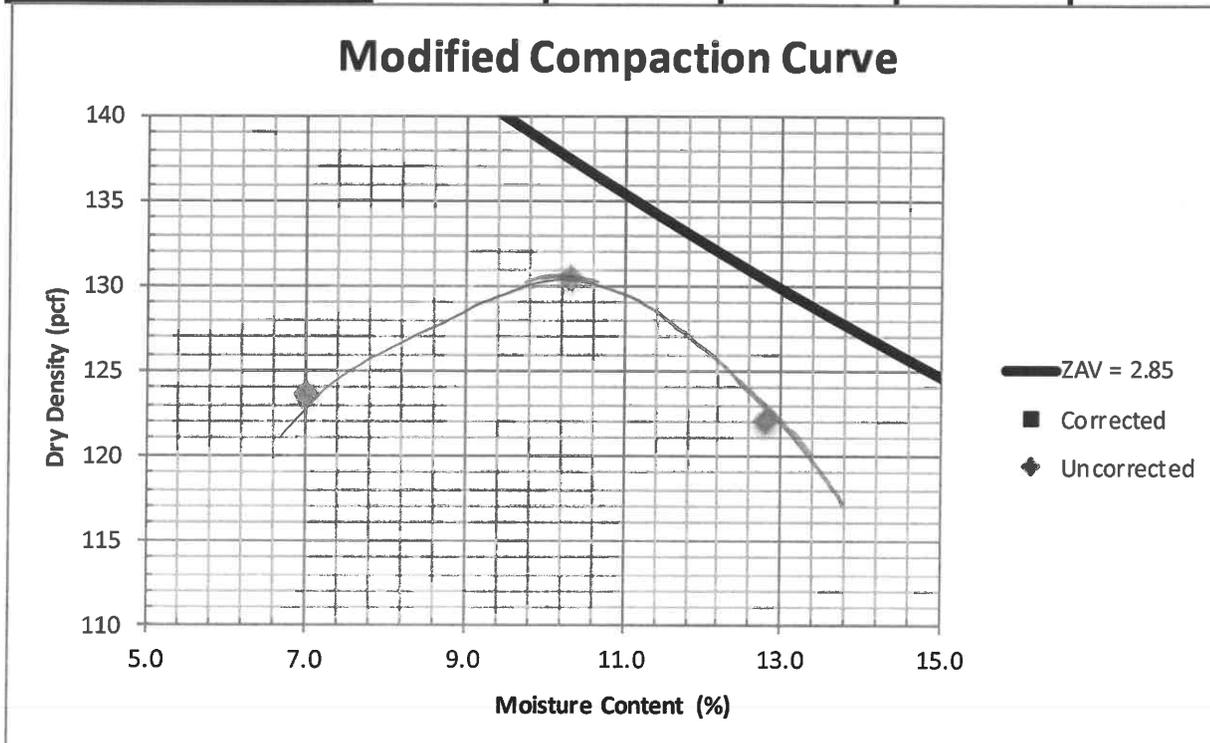
Sample ID: C3-subgrade

UNCORRECTED	CORRECTED
Optimum Moisture (%)	10.3	NA
Maximum Dry Density (pcf)	130.6	NA

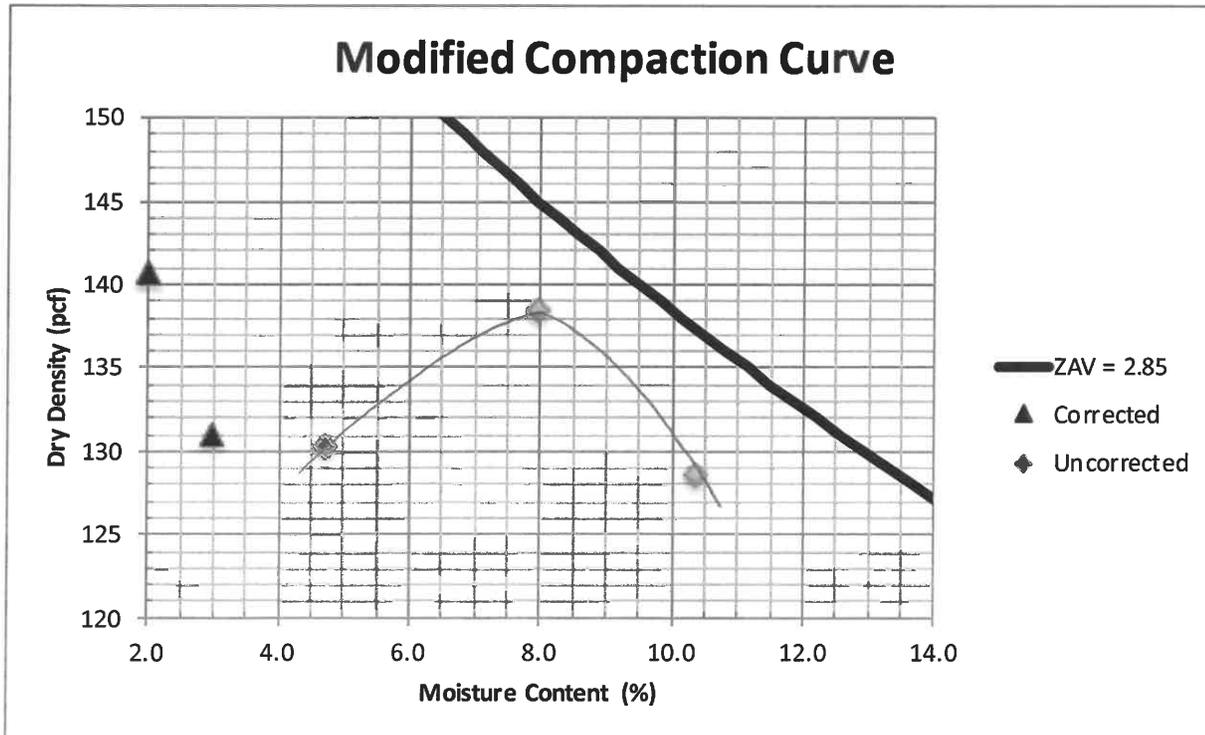
Sample ID: C5 subgrade

UNCORRECTED	CORRECTED
Optimum Moisture (%)	8	8
Maximum Dry Density (pcf)	138.5	140.7
