Livermore Area Recreation and Park District

Staff Report

SUBJECT: Tree Failure, Robert Livermore Park

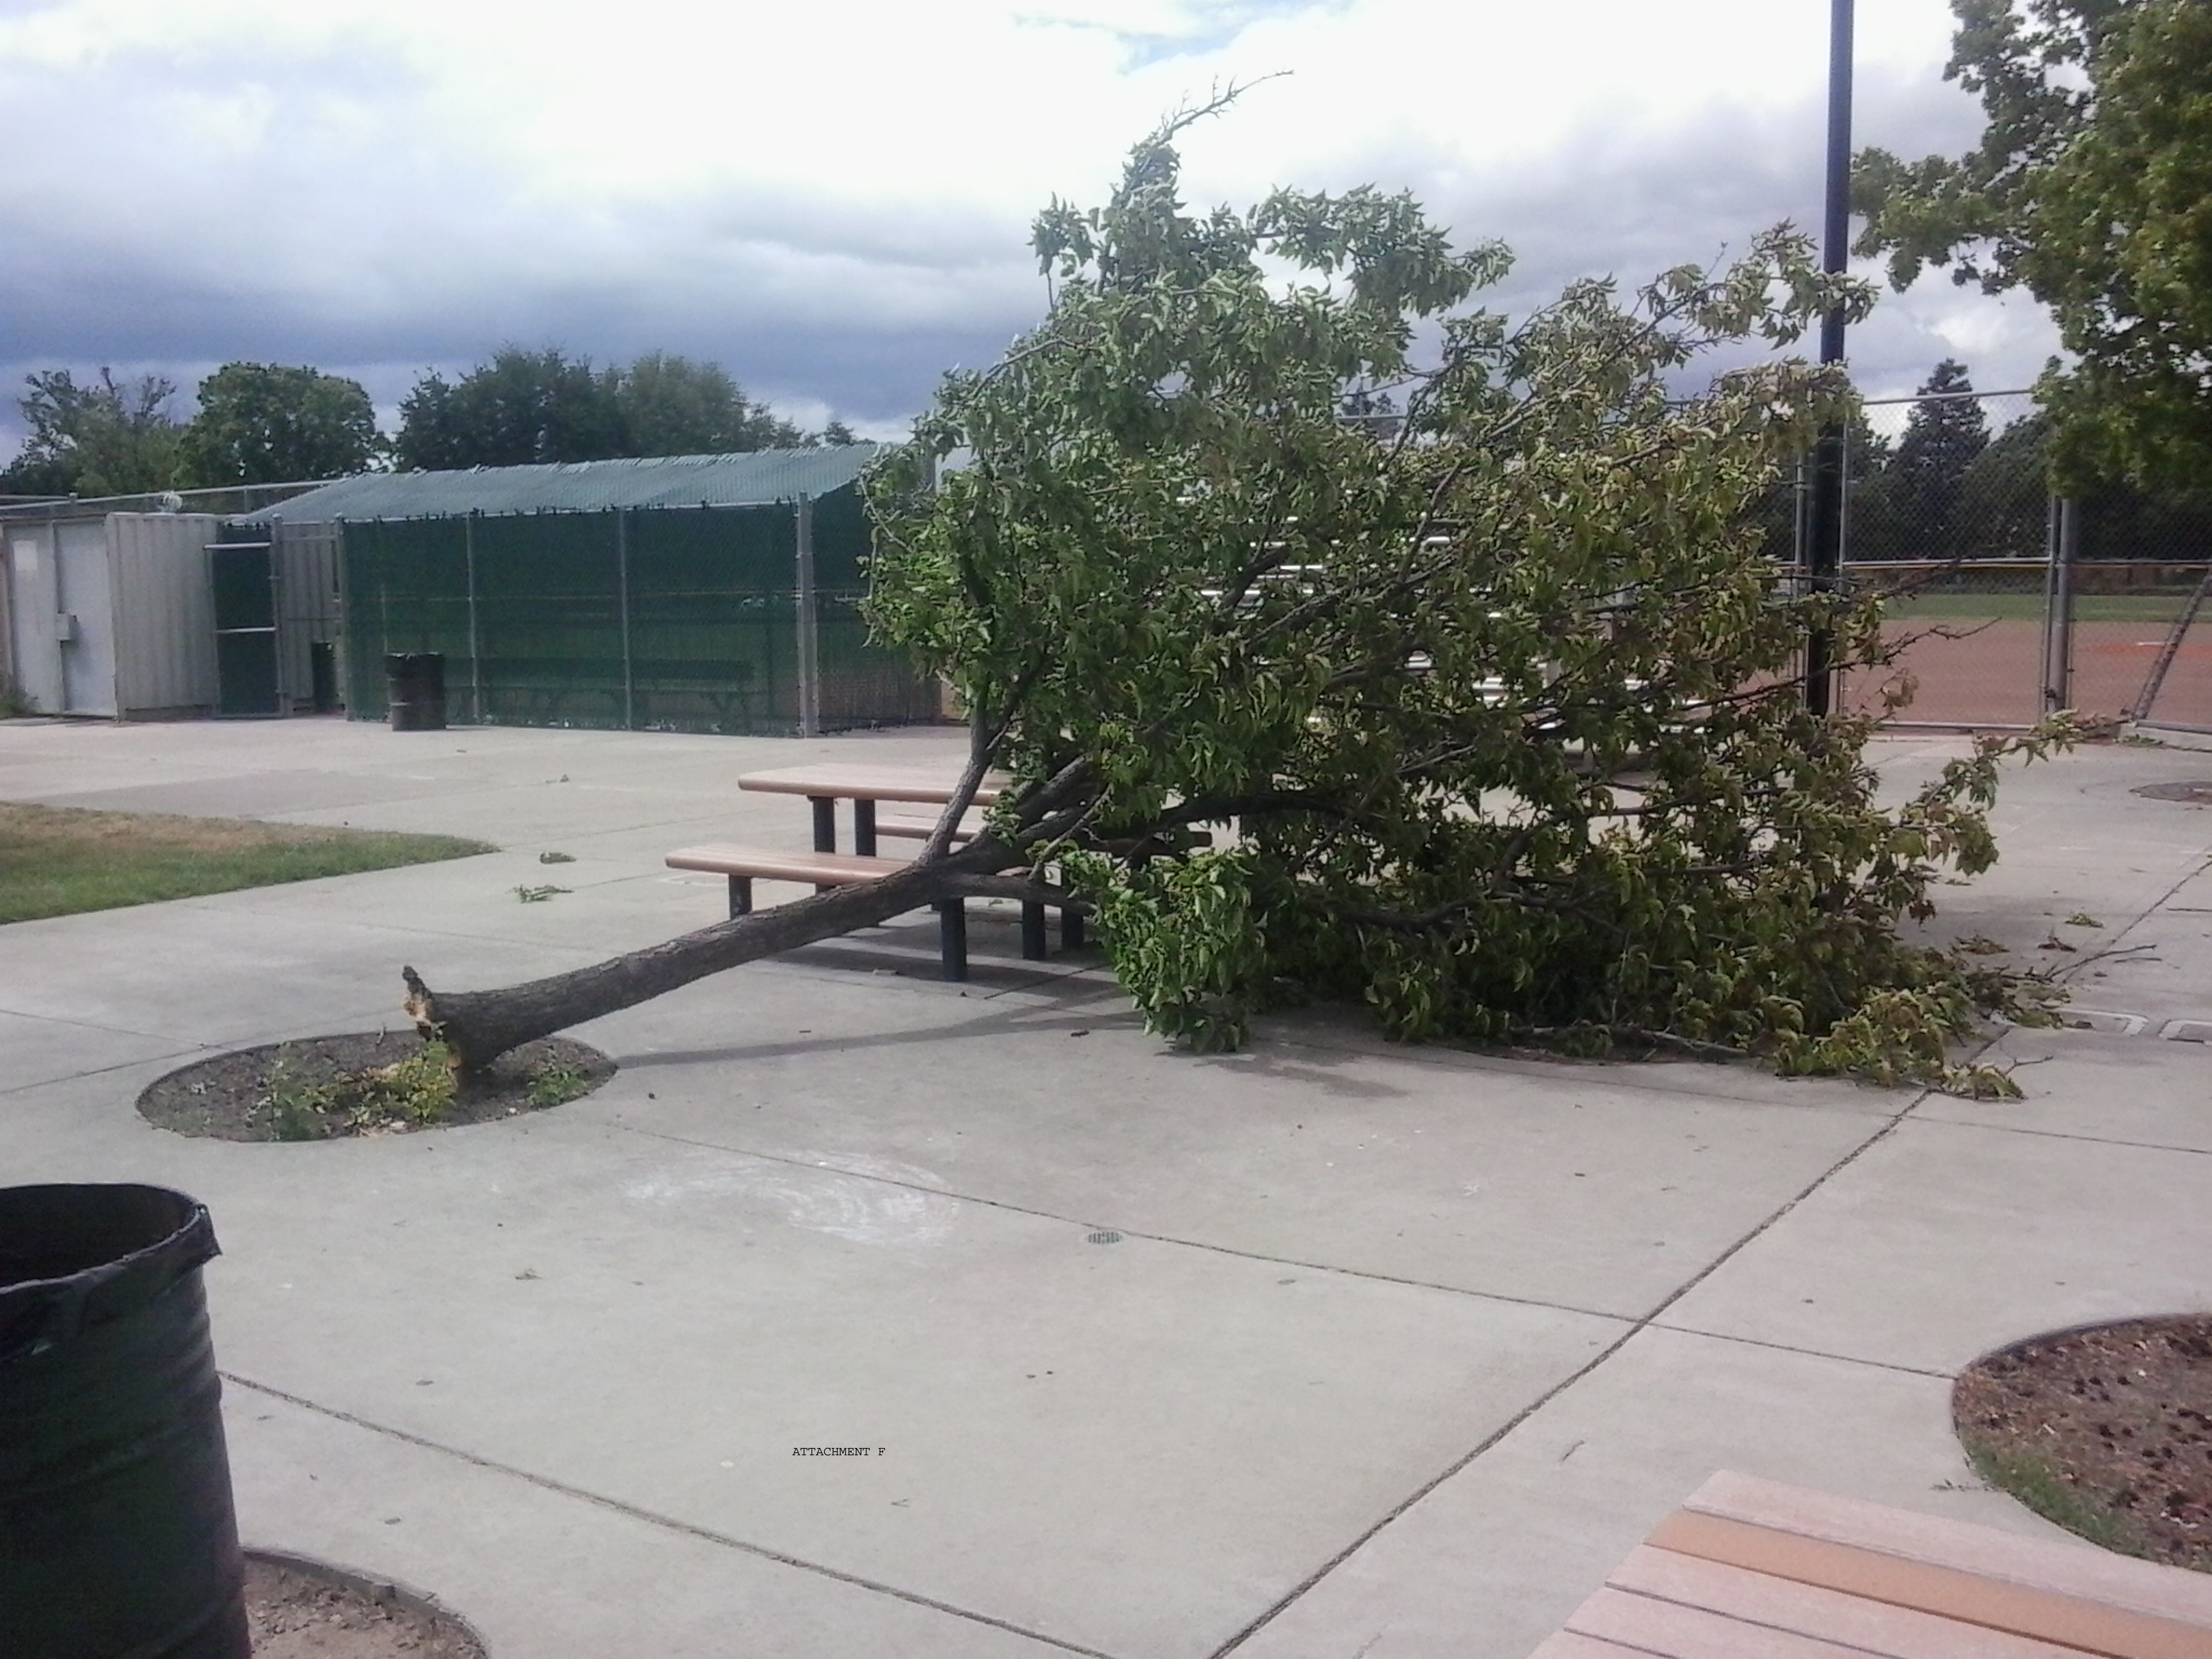
ATTACHMENT F

Flowering pear tree failed at the base of tree trunk at root flare of tree.
There was no indication of decay (appears to be white rot) around outside of tree.
There were no conks or mushrooms to indicate any decay, nor any cankers observed on tree trunk. Tree appeared to be ~~normal~~ normal with green leaves, (except black spot on leaves).
(see photos attached)

I observed white rot on inside of tree at failure point. Very little rot cavity observed.
(see additional photos to be attached)

- After the failure of the tree, appearance of internal trunk decay was evident. There was no external, visual evidence that would have suggested internal trunk decay to this degree. Foliage appeared healthy, crown was full and trunk appeared normal with no obvious signs of injury, conks, discoloration or seepage. Trunk could be considered small (in diameter) for a tree this age, due to less-than-ideal growing conditions.

- Tree was approximately 20 years old. A 25 year lifespan of trees of this variety, grown in these conditions, is not unusual.
- Summary: I believe the failure of the tree was possibly due to a couple of factors. The trunk decay is obviously the primary reason for failure. In a case such as this, pathogens can enter through the area of the crown, or graft, by way of mechanical injury or possible insect activity. Pathogens can then affect the internal stem of the tree without noticeably visible signs on the surrounding bark. This seems to be the case with this tree. While the tree would have failed eventually, the undersized trunk (with full crown) may have played a role in the failure at this specific time.

RECOMMENDATION: In Kevin Brown's observations regarding this species of tree (Attachment C), he describes the normal life span of this species to be 25 years on average. The trees in Robert Livermore Park are estimated to be approximately 20 years old. It is reasonable to assume that we will see more failures in the next five years. Staff is visually inspecting the remaining trees now, but as evidenced by this incident, visual inspection has limitations. It is my recommendation that the remaining trees be removed within the next five years and replaced with a hardier species. It should be noted that all of the trees in question are planted in four-foot tree wells within the parking lot. This is not an ideal condition for any tree. We might consider not replacing some/most of these trees at all. Doing so would require us to mitigate for the removal by planting 2-3 per tree removed elsewhere within the District.
