Livermore Area Recreation and Park District

Staff Report

SUBJECT: Tree Failure, Robert Livermore Park

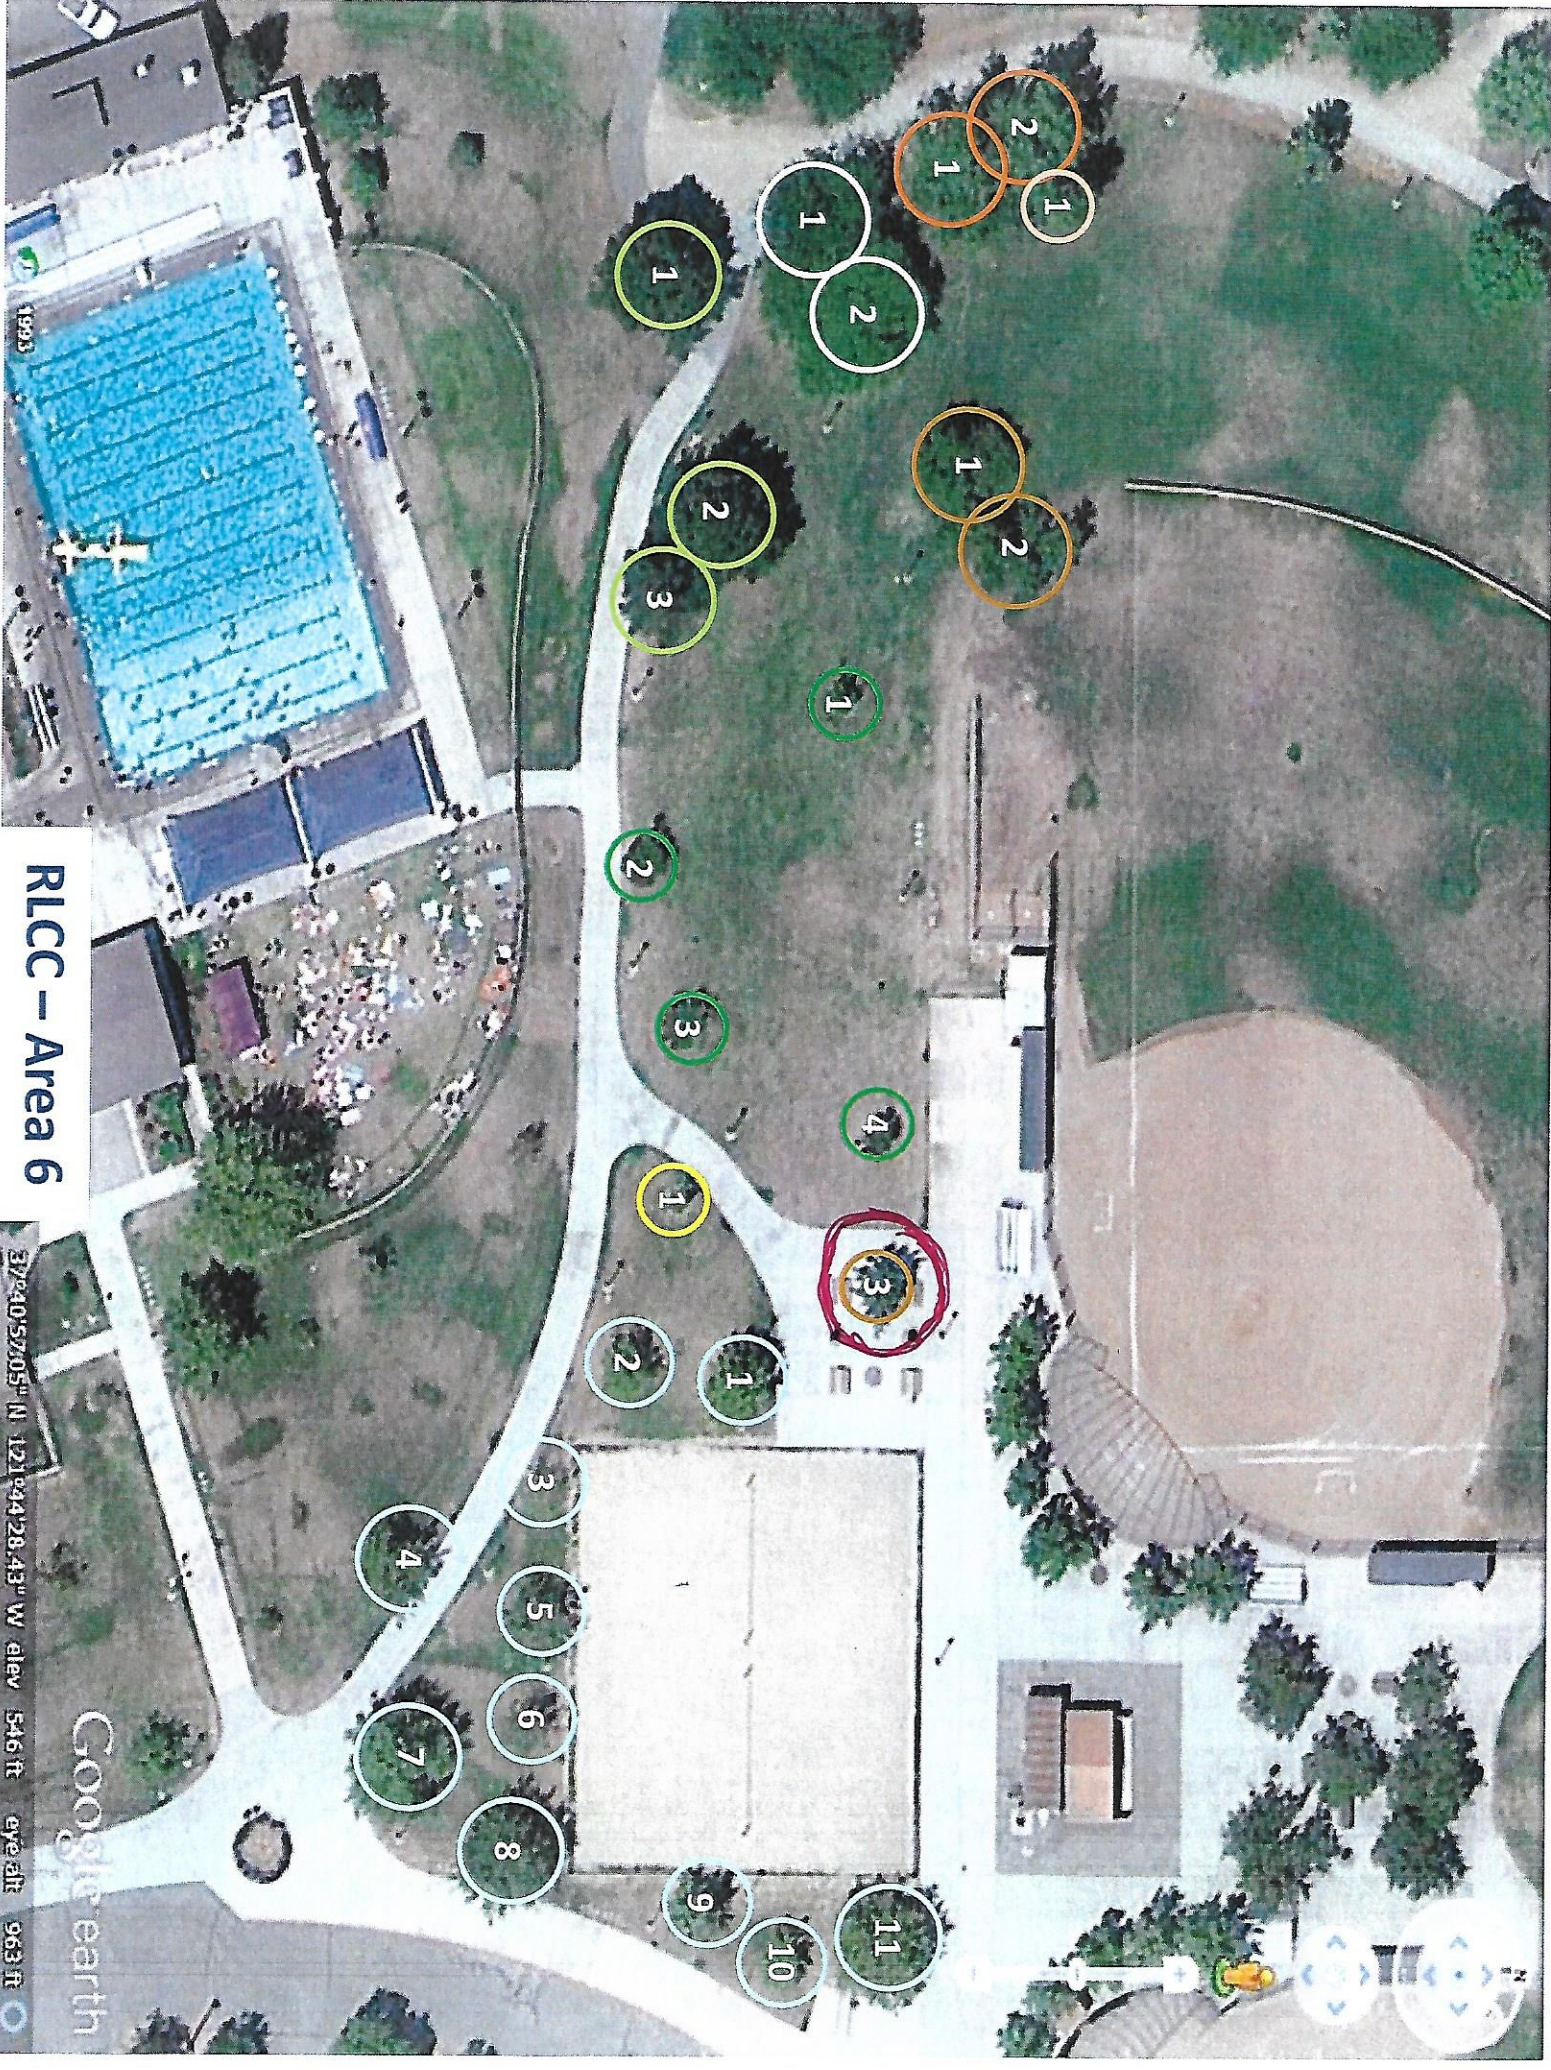
RLCC - Area 6

Lt. Blue	9	London Plane Tree	Platanus	acerifolia	40'	18'	22"	5
Lt. Blue	10	London Plane Tree	Platanus	acerifolia	20'	15'	16"	4
Lt. Blue	11	London Plane Tree	Platanus	acerifolia	40'	25'	38"	5
Brown	1	Flowering Pear	Pyrus	kawakami	25'	20'	36"	4
Brown	2	Flowering Pear	Pyrus	kawakami	25'	20'	37"	4
Brown	3	Flowering Pear	Pyrus	calleryana	20'	15'	19"	5
